Conservation Area Appraisal

Kingsdown

OCTOBER 2015

Part 1: Overview and Recommendations

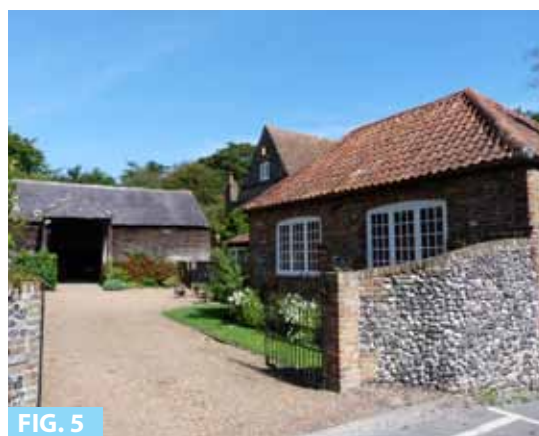
FIG. 5 *Dial Cottage, Upper Street.*

Dial Cottage, early 18th century, is a mixture of flint and red brick with wooden casement windows. The barns are of wooden construction and the large barn facing the street has an impressive full-height door, all appearing to be in good condition. In summer 2014, the smaller barn was severely damaged by fire. The wall adjoining the street shows evidence of repair over the years but is pleasing and warm.

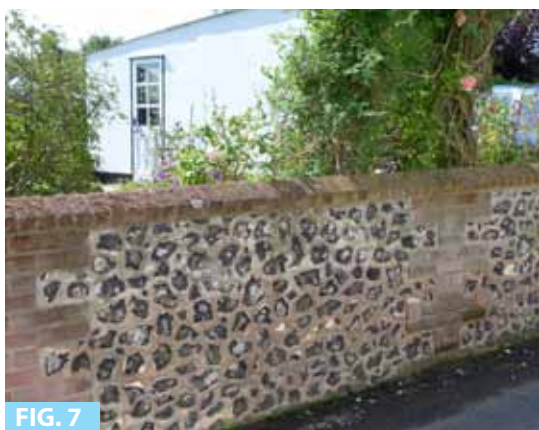
3. Boundary walls important to the street scene – especially flint – susceptible to damage, erosion, demolition.
4. Loss of substantial trees, impacting on the leafy character of the conservation area.

FIG. 7 *Flint wall in Upper Street.*

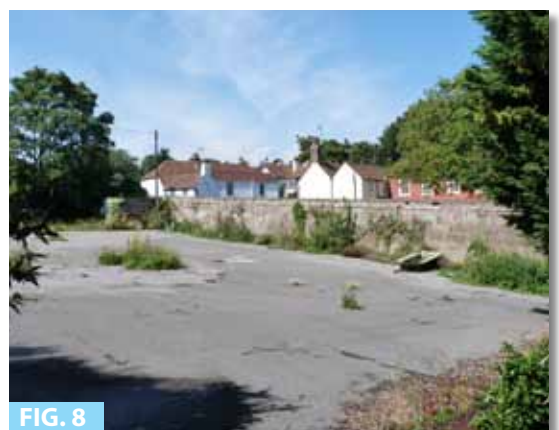
5. Pressure to build on gap sites and open land, which could be detrimental to the special character of the area.
6. The former car park site in Upper Street, vulnerable to inappropriate development.

FIG. 8 *Site of former car park in Upper Street.*

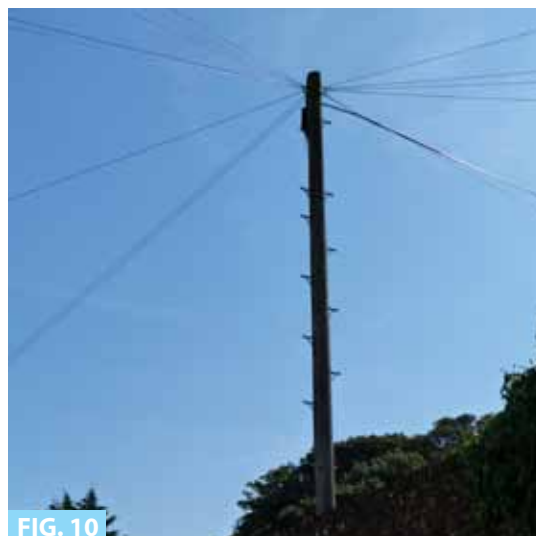
1. Telegraph pole and wires in Upper Street and electricity pole and wires in The Rise.

FIG. 10 Telegraph pole and wires in Upper Street.

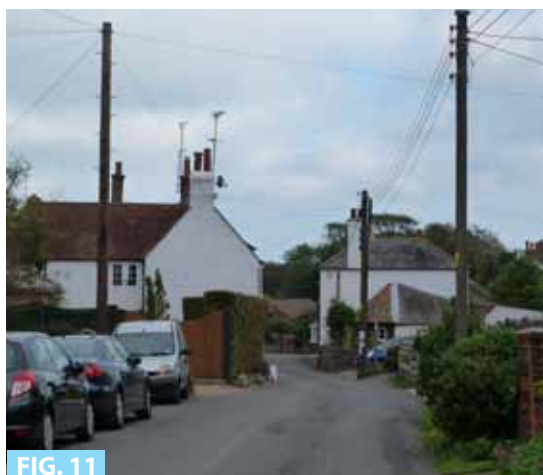
FIG. 11 Electricity pole and wires in The Rise.

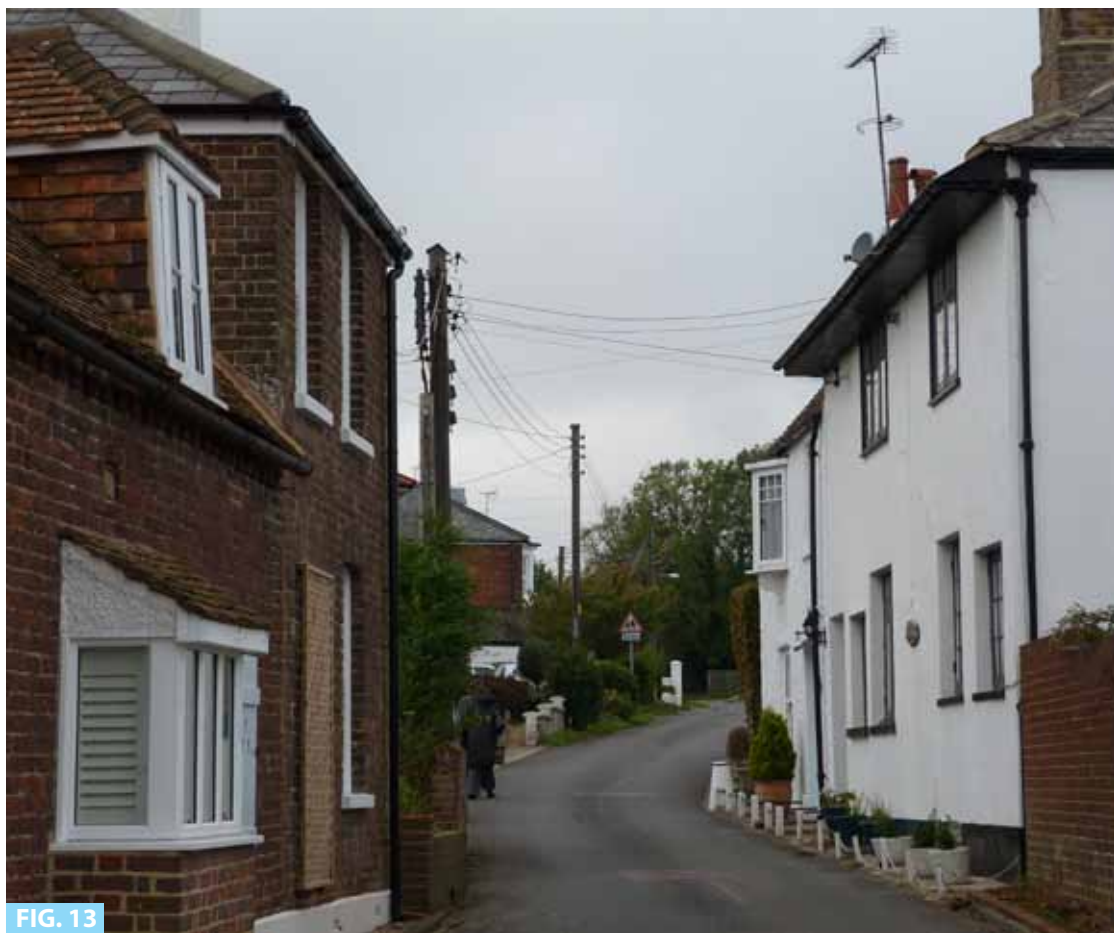
A group of buildings on the north side of The Rise, known as Mount Pleasant, lie opposite the current, northern boundary of the conservation area, numbers 1-4 Mount Pleasant being perpendicular to the road and 5-7 being on The Rise itself. Together with The Old Cottage and Mount Pleasant Cottage on the other side of the road, they clearly mark the transition from the later development to the west to the more historic environment of the conservation area itself. In visual terms they define the western limits of the conservation area's characteristic environment and it is

FIG. 13 *Mount Pleasant, The Rise, looking west.*

recommended that the conservation area boundary be formally amended to include them and their adjoining garden plots (note: this boundary extension also includes Holly Tree Cottage fronting The Rise).

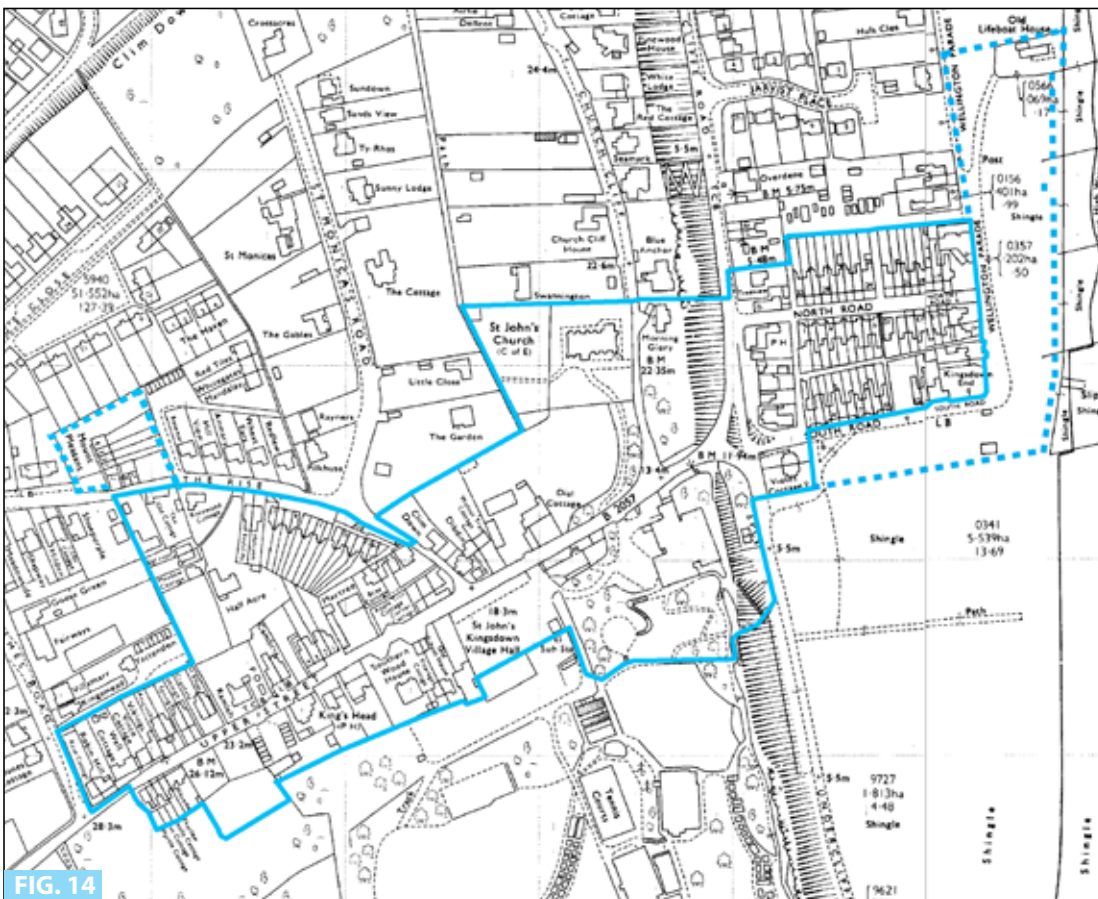
FIG. 14 Solid blue line shows extent of the current conservation area boundary. Dotted blue lines show suggested addition to conservation area at The Rise and the beach area.

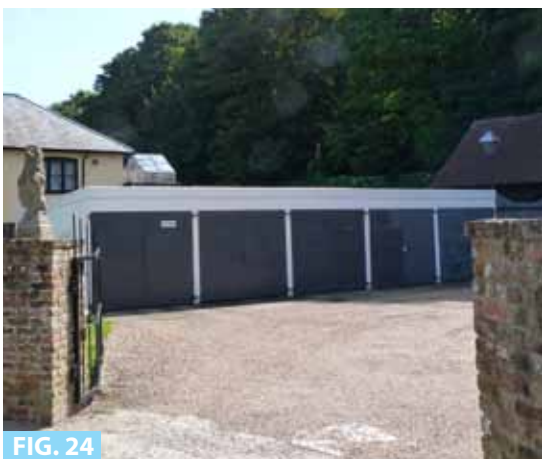
FIG. 24 Upper Street: the forecourt of the barn now contains two rows of garages.

The large barn next to The Kings Head is evidence of the agricultural history of the village. The forecourt now houses two rows of garages. Whilst this use does little to enhance the character of this part of the conservation area, the garages themselves (although of no architectural merit) are well kept and painted. They are a valuable asset to those who rent them, parking being a premium in the village. The barn, of flint

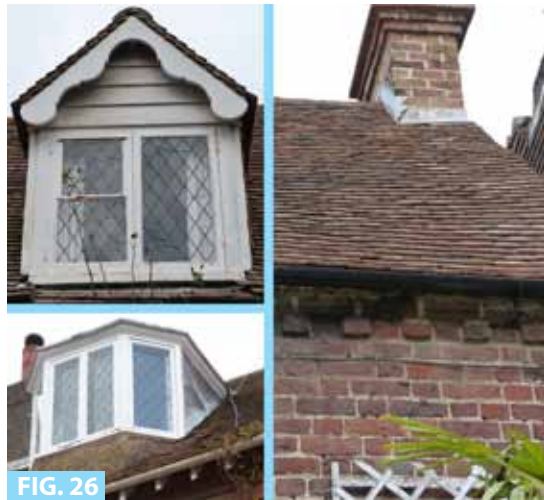
FIG. 26 Details of Upper Street cottages: leaded light casement windows, dormers, attractive corbelling and eaves detailing at the roof line.

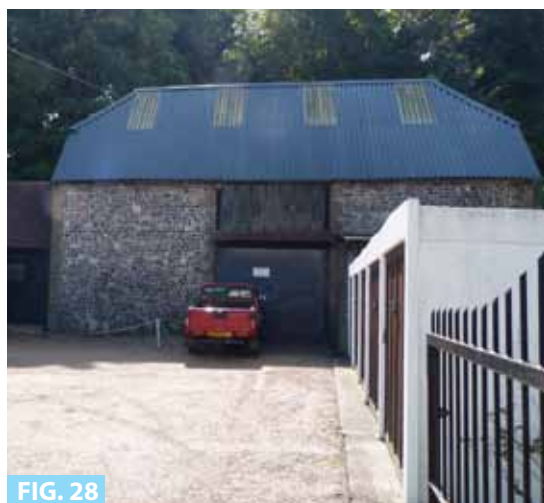
FIG. 28 The large barn next to The Kings Head, with two rows of garages in forecourt.

construction, itself appears to be in good condition although the roof has been repaired at some stage. Imposing entrance with stone lions atop the gate posts. The Kings Head has been carefully restored and painted in recent years, with its coloured rendering adding to the cosiness of this part of the village.

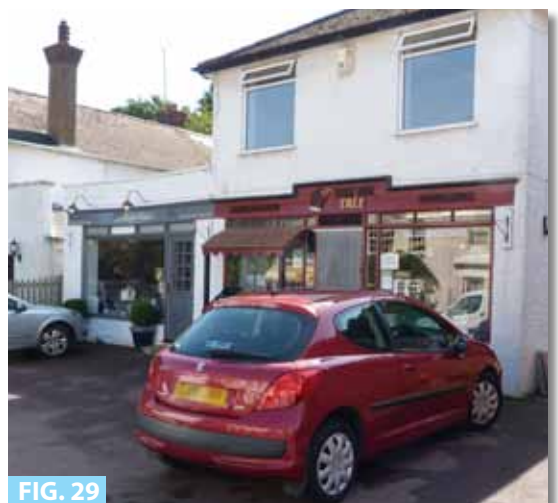
FIG. 29 Upper Street shops were originally houses, built in the 1930s.

The shops are a very important part of the village and help to keep the village alive. The open areas in front of the shops are gathering places for locals and visitors to exchange greetings and gossip! These shops were obviously originally houses, built in the 1930s, but the shop fronts are of no particular design or style. Beech Villa, now a house, was once a shop.

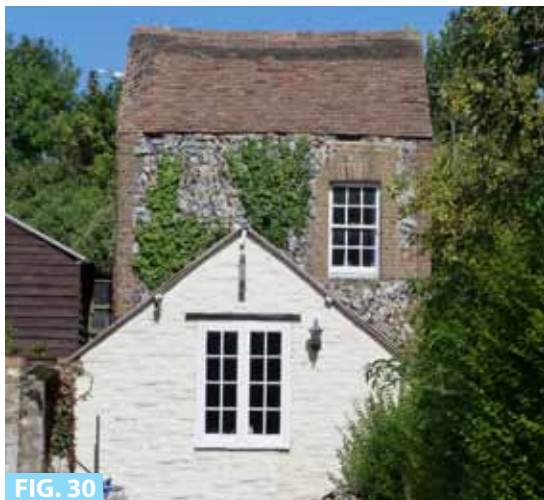
and dormers. Between Maytree and the Village Shop, set well back from the street, is a two-storey flint building that once was a fishing hanger. Flint plays a major part in the construction of the wall adjoining the road in front of Maytree, as it does in many of the garden walls. Some of this wall has collapsed.

FIG. 30 *Two-storey flint building that once was a fishing hanger.*

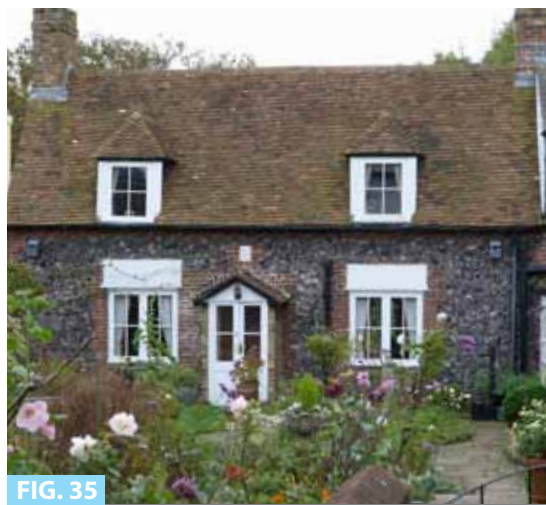
back off the road, with a lovely front garden, and retains the architecture of its period. Its flint construction, small porch and windows are well kept. The Old Cottage (1748) fronts directly onto the road and has recently been the subject of refurbishment where wooden framed windows have been replaced.

FIG. 35 *Mount Pleasant Cottage.*

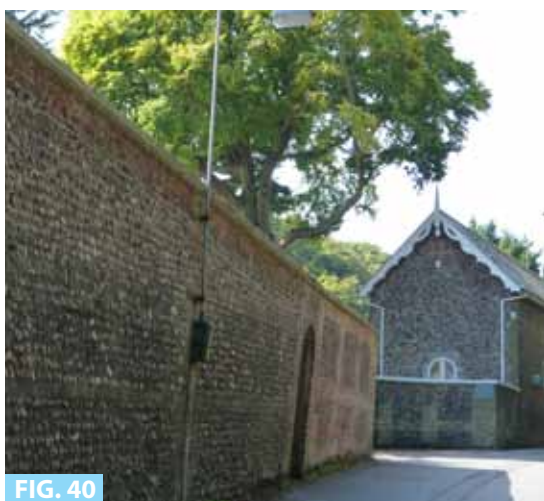
FIG. 40 *Flint wall on Upper Street.*

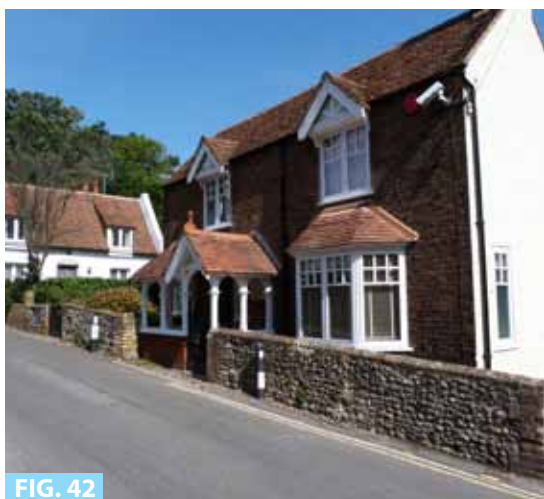
Clim Down, said to date from 1704, and Hillside are two of the oldest cottages/ houses in the village, brick built and partly painted. Hillside has an attractive porch on its entrance to The Rise and uses flint in the construction of the wall surrounding it. A large anchor sits in front of Clim Down.

FIG. 42 *Clim Down and Hillside.*

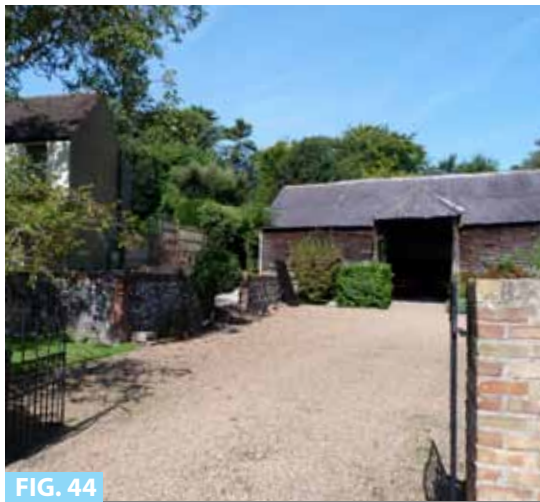
FIG. 44 Forecourt and barns of Dial Cottage.

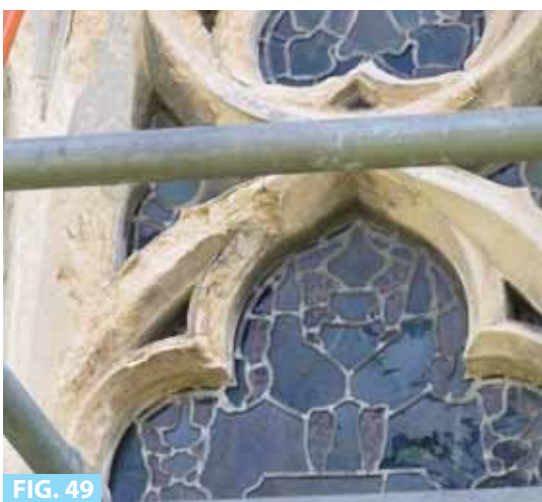
FIG. 49 *Decaying stonework of St John's Church.*

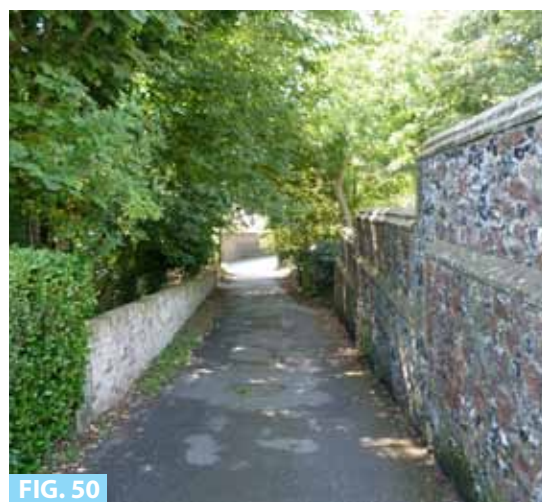
FIG. 50 *View of the church wall looking down Church Cliff towards Upper Street.*

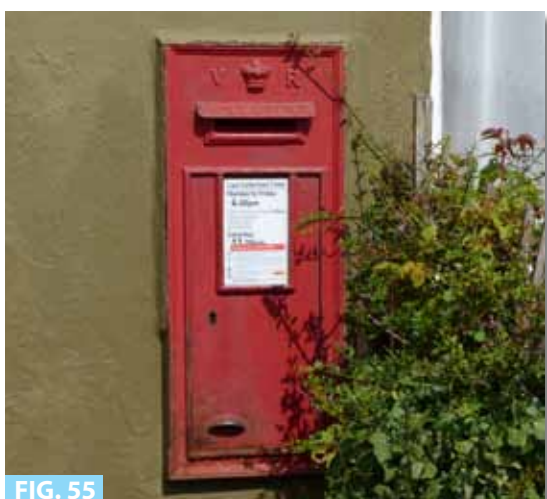
FIG. 55 *VR postbox in wall of house in South Road.*

At the sea end of South Road is a larger house, distinctive both in size and the coloured rendering. In its front wall is an original post box marked VR, a reminder of its past history as the old post office. A large cedar tree in the garden provides a striking visual feature.

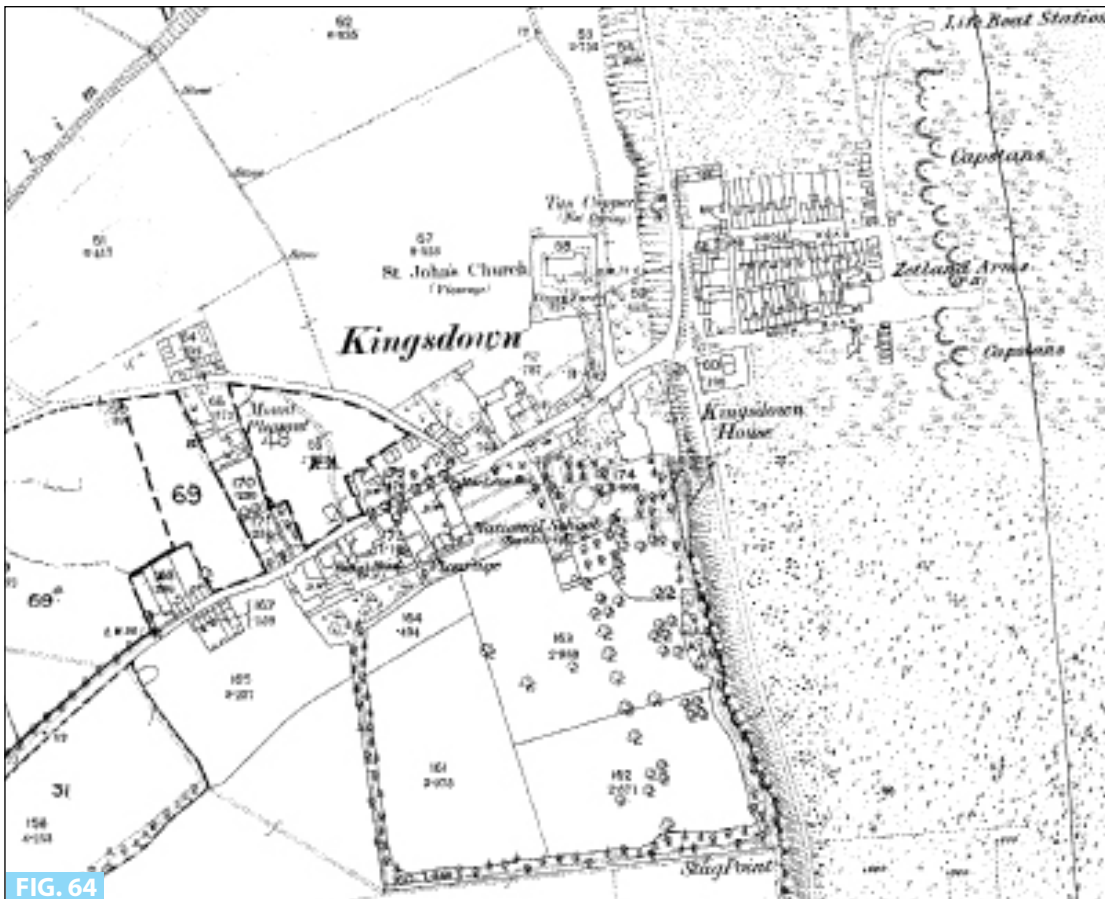
FIG. 64 Kingsdown village in 1871-2.

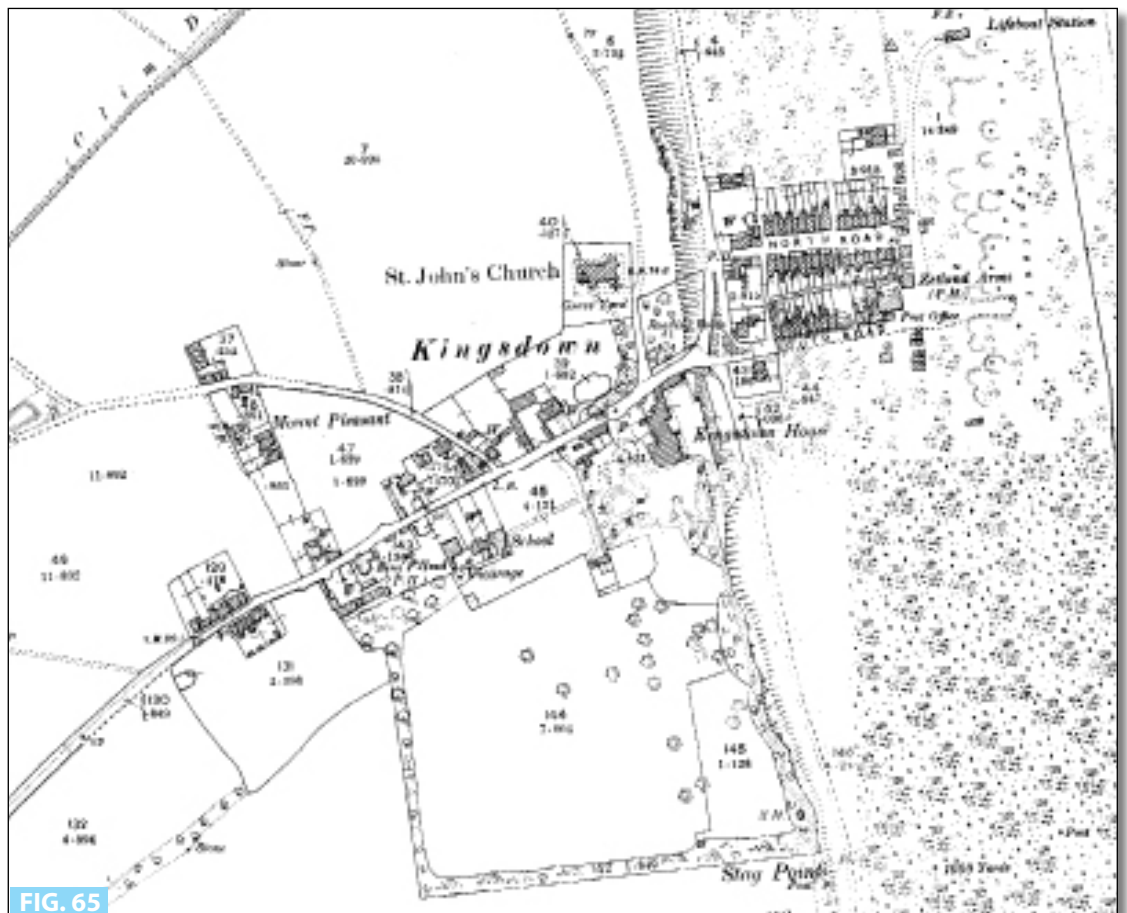
FIG. 65 Kingsdown village in 1898.

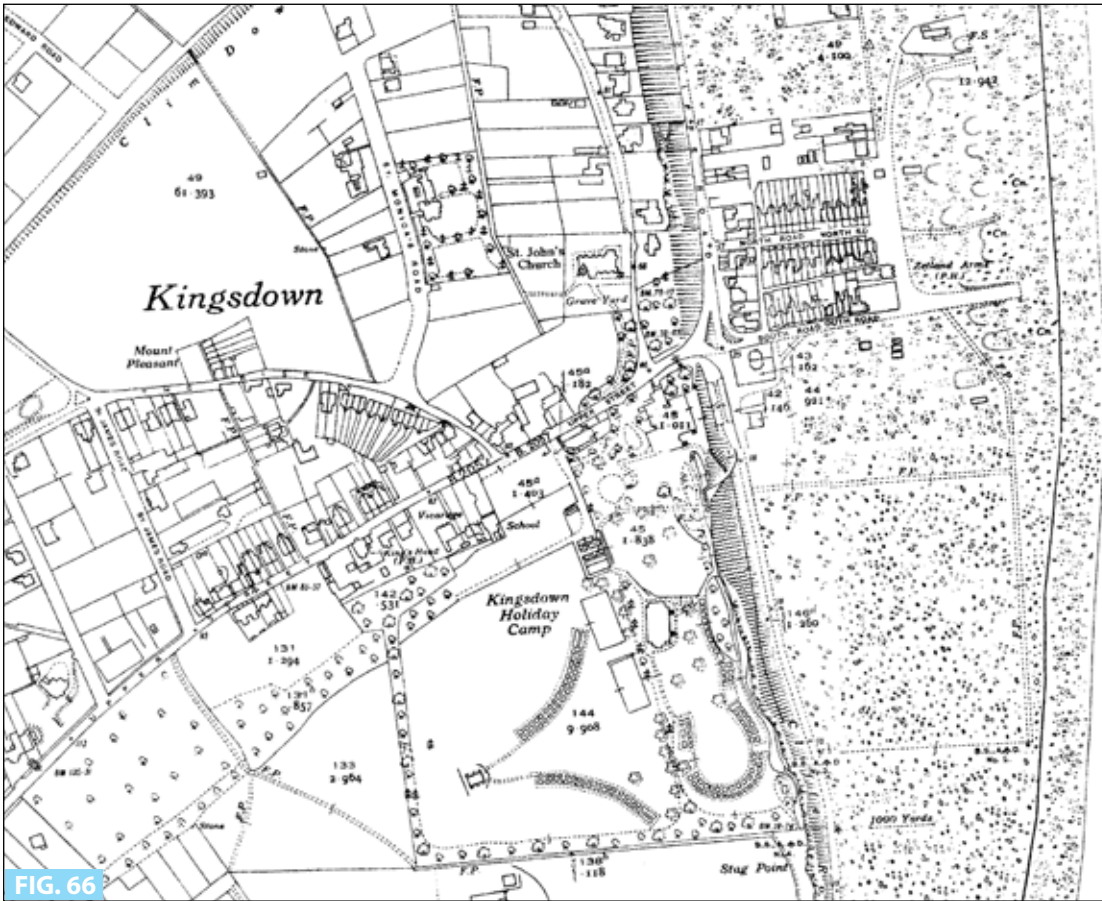
FIG. 66 Kingsdown village in 1938-45.

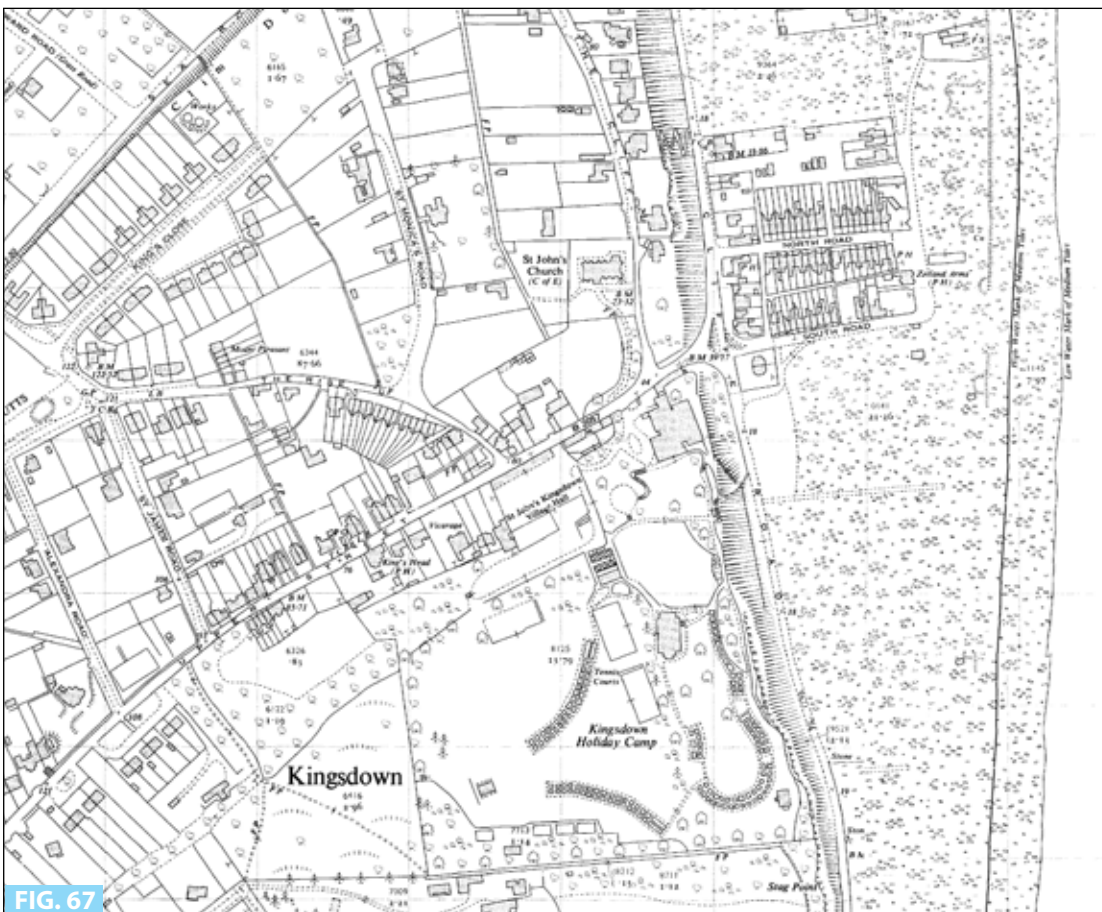
FIG. 67 Kingsdown village in 1958.
