Conservation Area Appraisal

Kingsdown

OCTOBER 2015

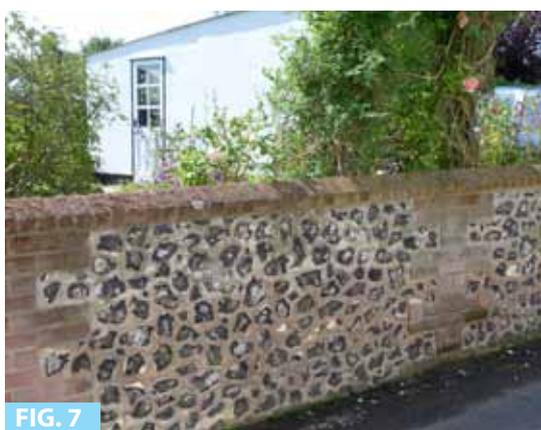
3. Boundary walls important to the street scene – especially flint – susceptible to damage, erosion, demolition.
4. Loss of substantial trees, impacting on the leafy character of the conservation area.

FIG. 7 *Flint wall in Upper Street.*

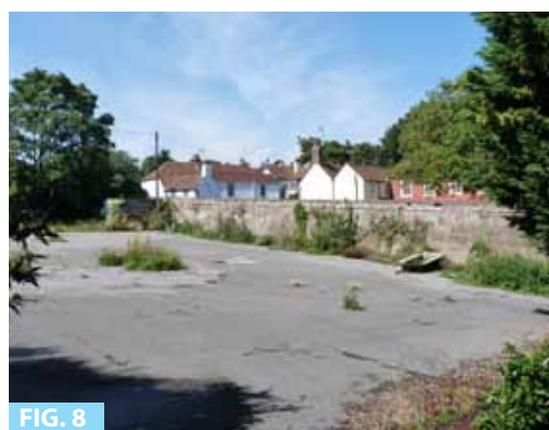
5. Pressure to build on gap sites and open land, which could be detrimental to the special character of the area.
6. The former car park site in Upper Street, vulnerable to inappropriate development.

FIG. 8 *Site of former car park in Upper Street.*

4. Unkempt, vacant site of the former car park in Upper Street.

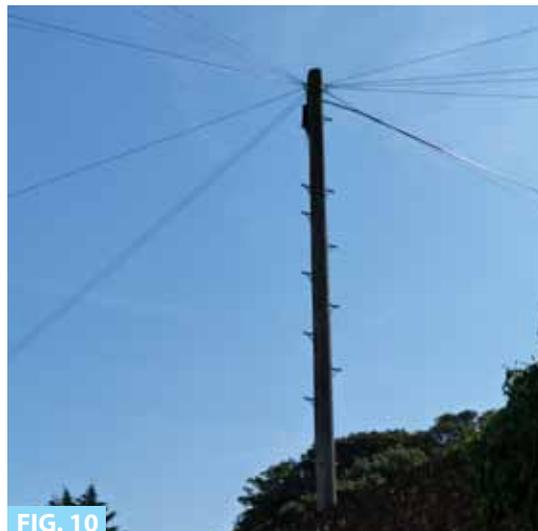
1. Telegraph pole and wires in Upper Street and electricity pole and wires in The Rise.

FIG. 10 Telegraph pole and wires in Upper Street.

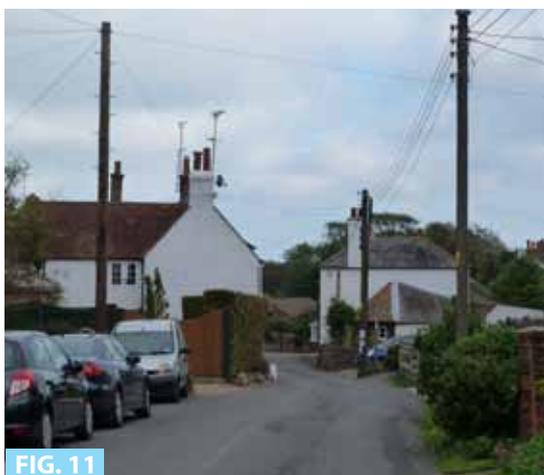
FIG. 11 Electricity pole and wires in The Rise.

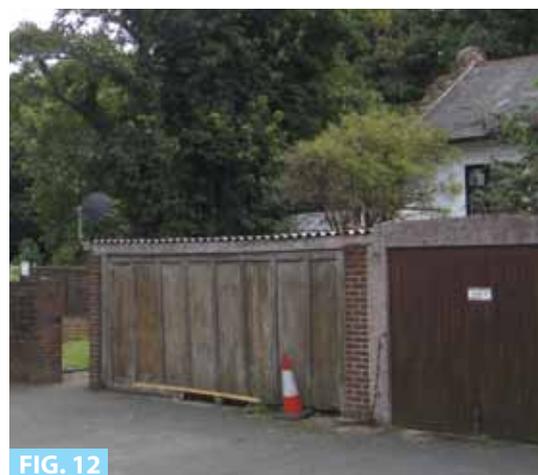
3. Garages in front of The Old School House/ Vicarage Cottage, Upper Street.

FIG. 12 Garages and satellite dish in front of The Old School House/ Vicarage Cottage, Upper Street.

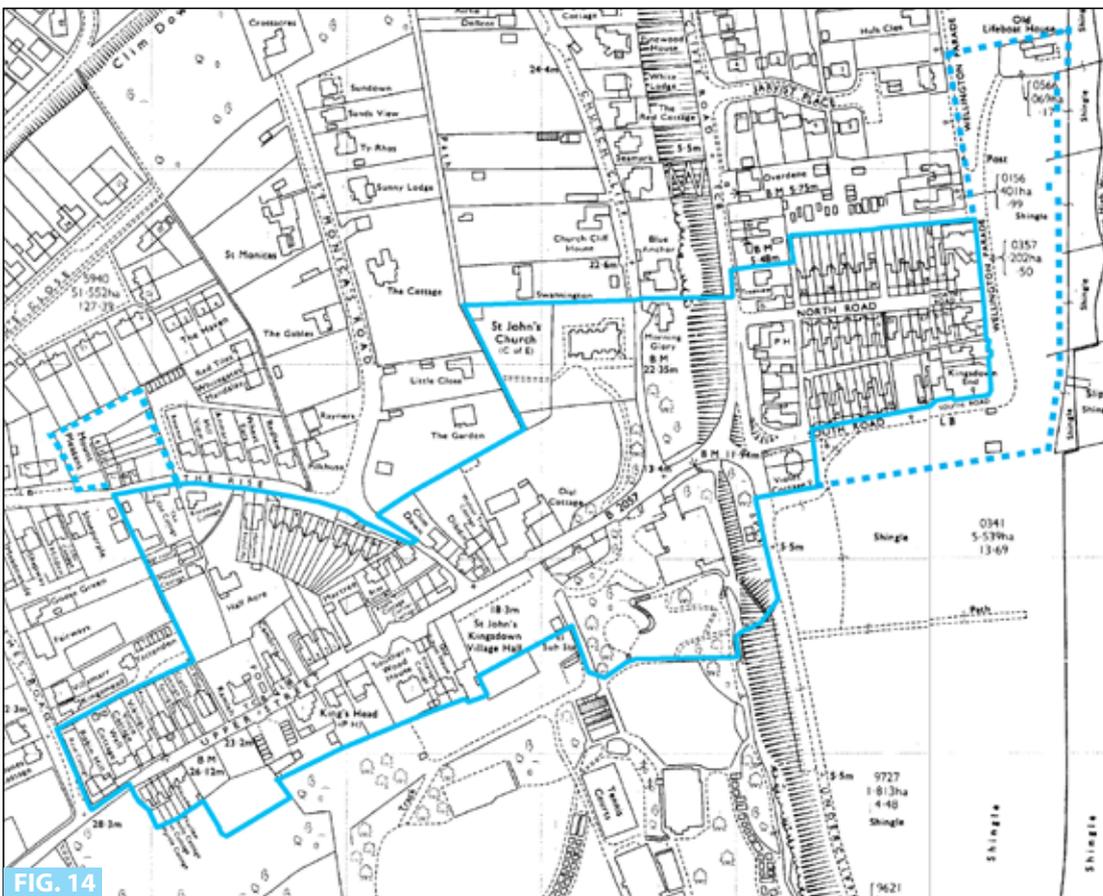
FIG. 14 Solid blue line shows extent of the current conservation area boundary. Dotted blue lines show suggested addition to conservation area at The Rise and the beach area.

recommended that the conservation area boundary be formally amended to include them and their adjoining garden plots (note: this boundary extension also includes Holly Tree Cottage fronting The Rise).

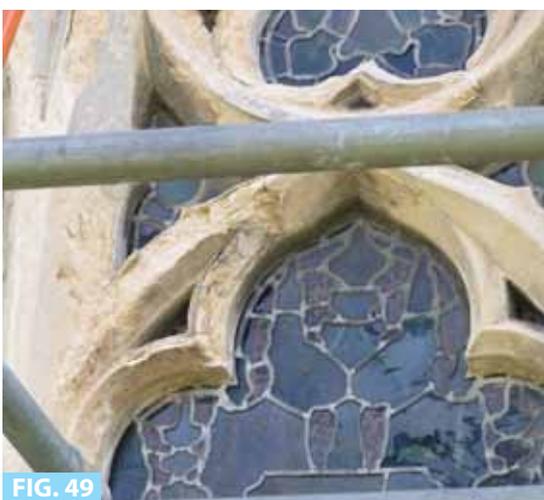
FIG. 49 *Decaying stonework of St John's Church.*
